VIBRATORY-STRESS INVESTIGATION OF SIX- AND EIGHT-BLADE
DUAL-ROTATING PROPELLERS OPERATING AT ZERO ADVANCE

By Atwood R. Heath, Jr. and Robert L. O'Neal

Langley Aeronautical Laboratory
Langley Field, Va.

RESEARCH MEMORANDUM

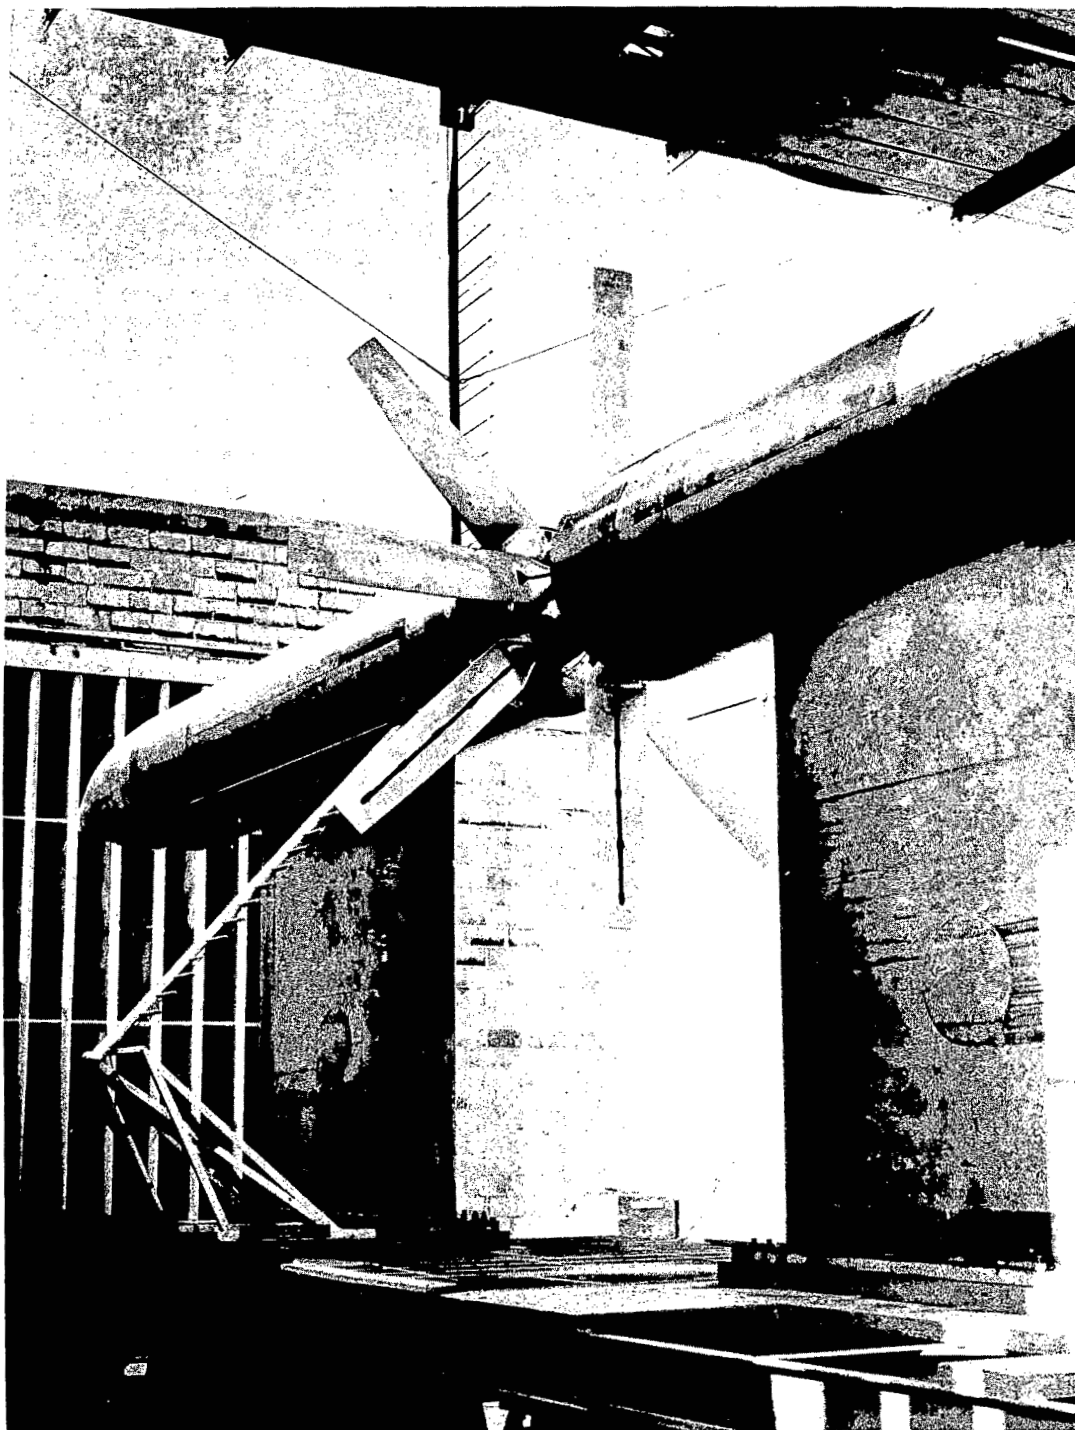
L-78831.1

Figure 1.- Three-quarter front view of the 8-blade configuration of NACA 8.75-(5)(05)-037 dual-rotating propeller installed on NACA 6,000-horsepower propeller dynamometer in Langley propeller static test stand.

NACA 6,000-horsepower propeller dynamometer.- The two units of the NACA 6,000-horsepower propeller dynamometer were installed at the Langley propeller static test stand. Figure 1 is a three-quarter front view of the installation and shows the eight-blade propeller in operating position. The two components of the propeller were mounted between the dynamometer units and were operated independently of each other. Looking at the propeller from the rear, the front component rotated clockwise and the rear counterclockwise. Although the two units of the dynamometer operated independently of each other, equal rotational speeds were maintained to within $1/4$ rpm. Rotational speeds were measured by means of shaft-tachometer readings that were matched with the known frequency of a tuning fork. A more complete description of the dynamometer is given in reference 3. No spinners were used for this investigation.

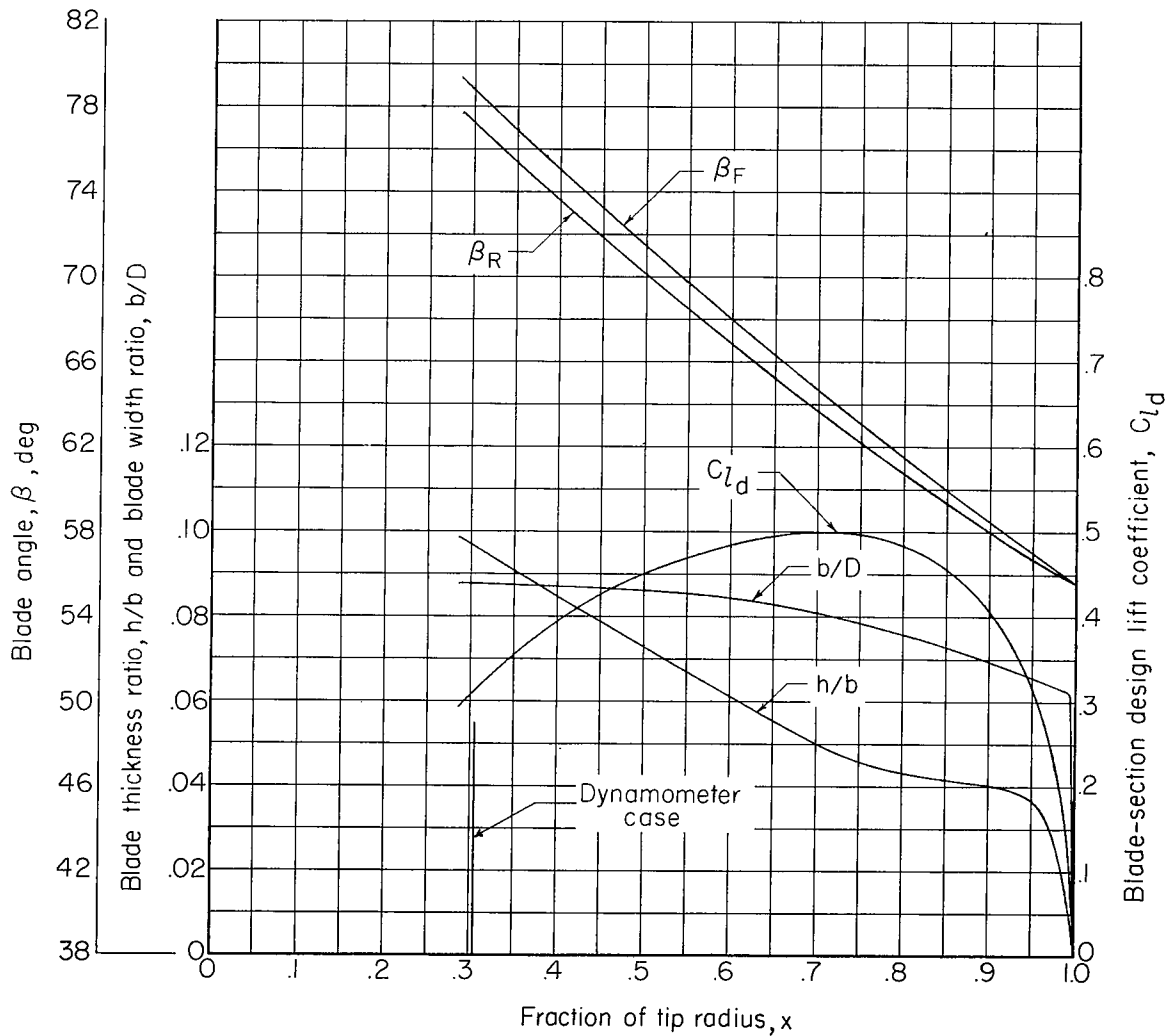
Developed plan form

Figure 2.- Blade-form curves and developed plan form for NACA 8.75-(5)(05)-037 dual-rotating propeller.

Propeller blades.- The propeller blades were NACA 8.75-(5)(05)-037 dual-rotating blades. The first number of the designation refers to the diameter of the propeller in feet. The remaining portion refers to the blade geometry at the 0.70-radius station: (5) indicates a design lift coefficient of 0.50, and (05) indicates a thickness ratio of 0.05. The final number, 037, indicates a solidity of 0.037 per blade. NACA 16-series airfoil sections were used for the blades which were made of solid aluminum alloy. Figure 2 shows the blade-form curves and developed plan form of the propeller blades. The blade chord is tapered from 9.226 inches at the 0.286 radius to 6.920 inches at the 0.950 radius, and the thickness ratio is diminished from 0.099 at the 0.286 radius to 0.037 at the 0.950 radius. The design advance ratio of the propeller was 4.2 at a forward Mach number of 0.8. A spacing of $13\frac{1}{8}$ inches between planes of the front- and rear-propeller components was maintained for the entire investigation.

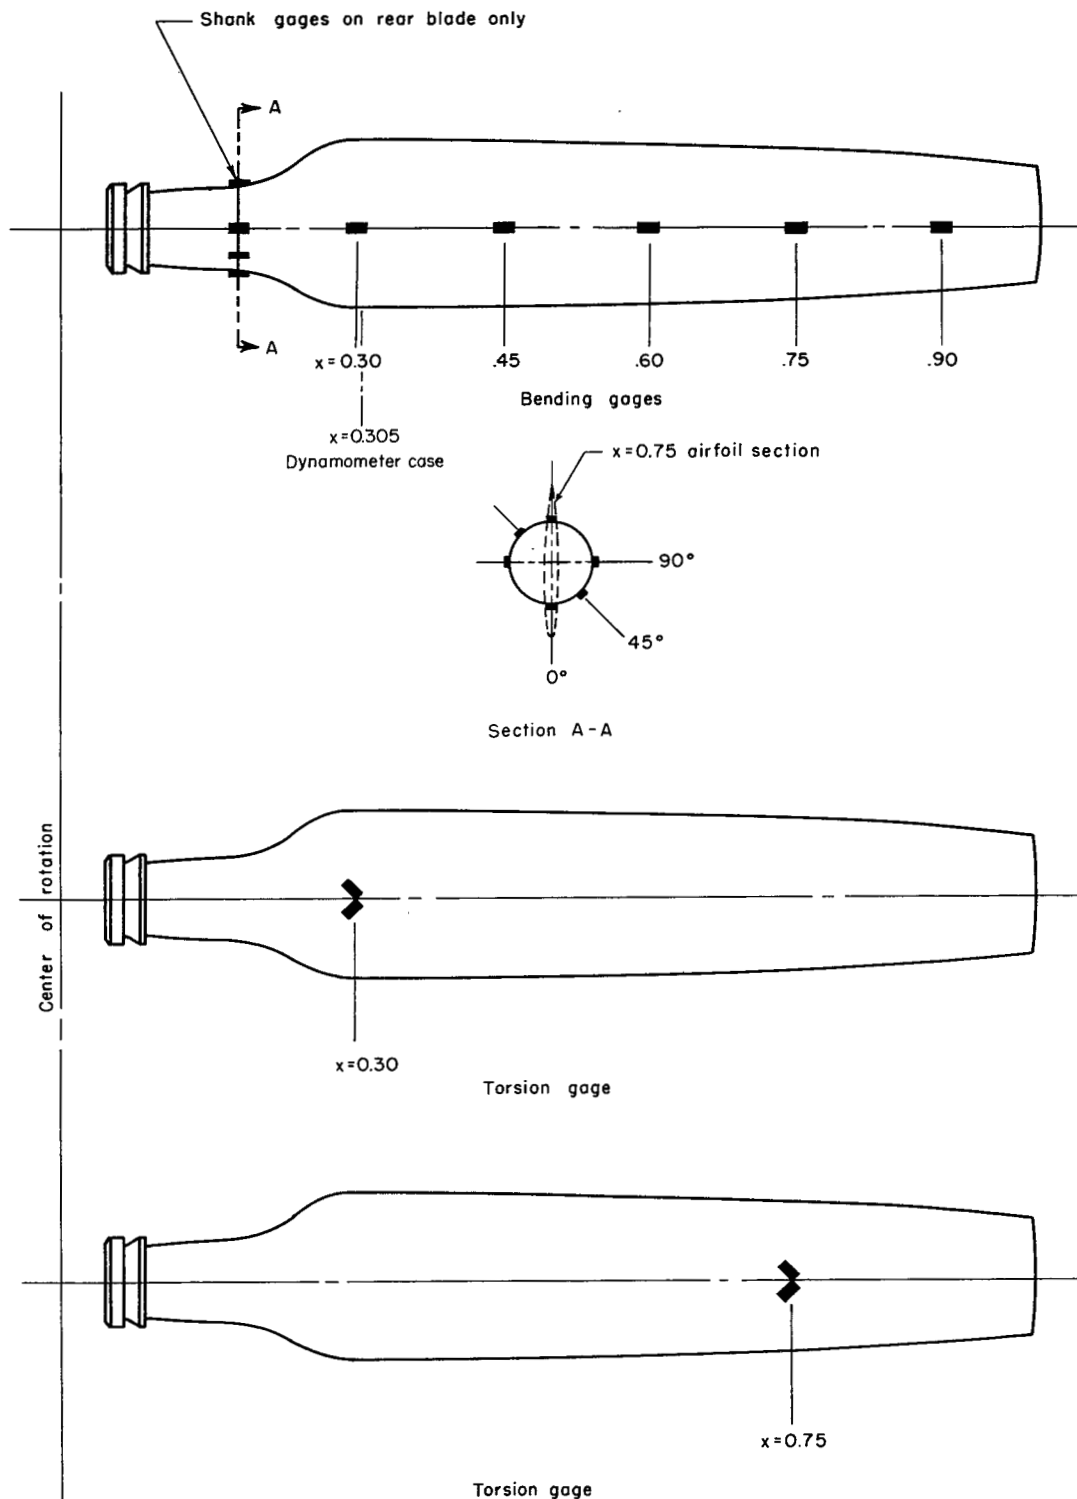
Figure 3.- Developed plan form of NACA 8.75-(5)(05)-037 dual-rotating propeller showing strain-gage locations.

Instrumentation.- Phenolic-bonded wire strain gages were used to measure the vibratory stresses. Strain gages arranged to measure flatwise bending stresses were distributed along the cambered surface of one blade of each of the front- and rear-propeller components. Strain gages for measuring torsional stress were located on the cambered surface of one blade of each propeller component at the 0.75-radius station for all tests of the six-blade configuration and part of the tests of the eight-blade configuration. Two other torsional gages were located on one other blade of each component at the 0.30-radius station and were operative for only part of the tests on each configuration. Shank bending was measured by gages located at 0° , 45° , and 90° related to the chord line at the 0.75-radius station on the same blade of the rear component as the flatwise bending gages. The strain-gage locations are shown on a developed plan form of the blade in figure 3. A limited number of amplifiers necessary for strain-gage operation were available so that only a part of the stress data could be obtained for any given test. Table I gives the number of strain gages and their locations for the various tests.

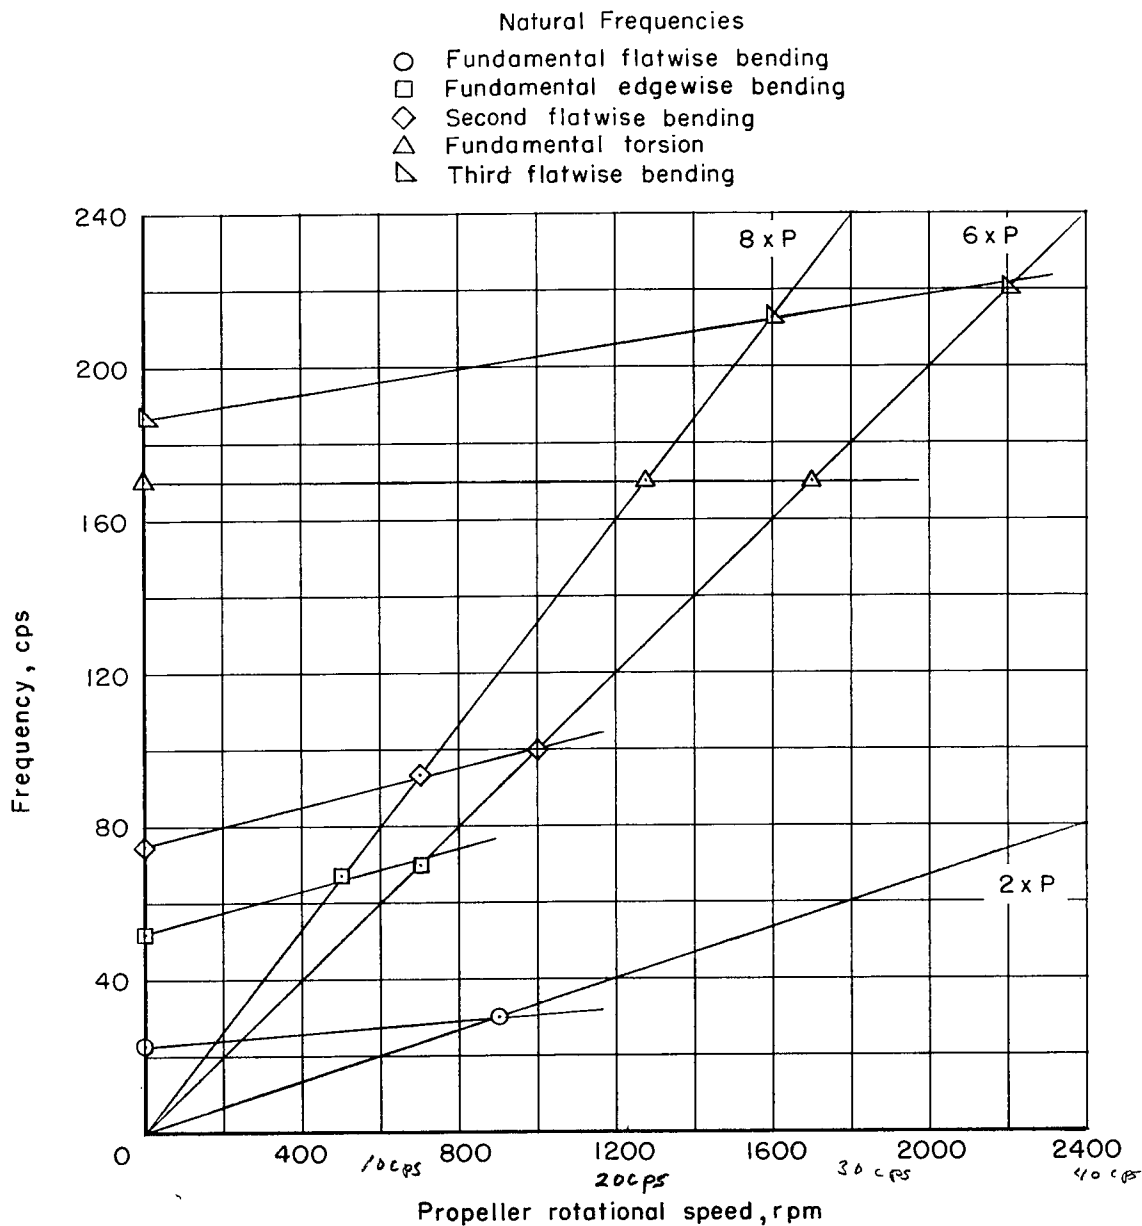
Figure 4.- Measured static natural frequencies and approximate measured resonant frequencies of NACA 8.75-(5)(05)-037 dual-rotating propeller blades and important orders of excitation.

Figure 4 shows the approximate measured resonant frequencies, the measured static natural frequencies of the propeller blade, and the propeller orders of excitation. The static natural frequencies were slightly different for each blade; therefore, average values are given. The curves have been drawn to tie together related points and will only approximate the variation of the natural frequencies with propeller rotational speed. In the case of the bending modes, the rotational natural frequencies would be expected to vary with blade angle, but the frequencies could not be determined with sufficient accuracy to show any definite variation; therefore, approximate values are given. The only modes of vibration at blade-passage frequency detectable in the operating range were fundamental edgewise bending, second and third flatwise bending, and fundamental torsion.

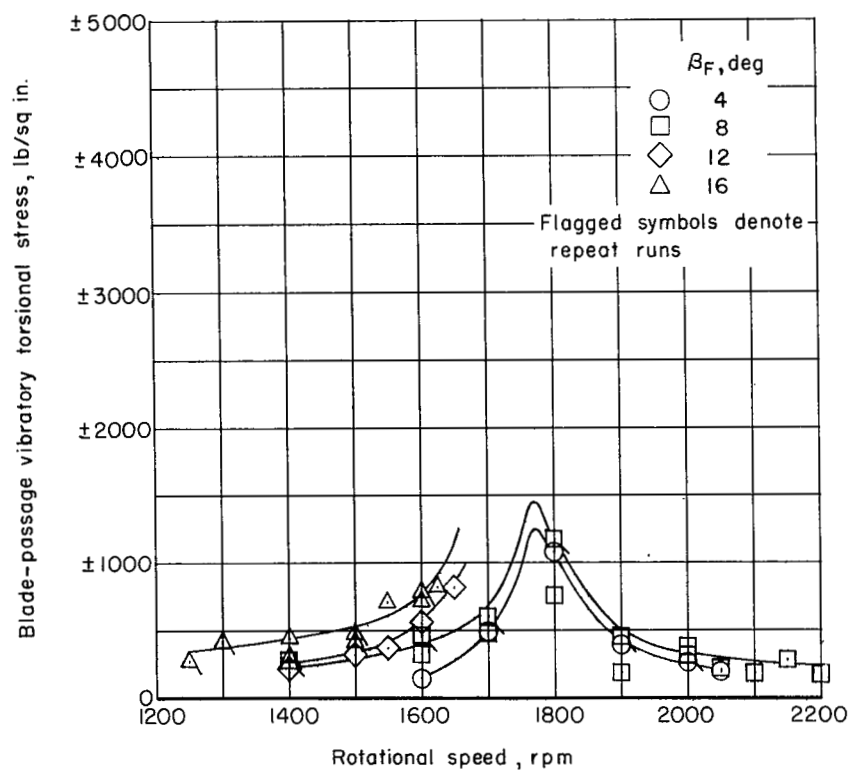
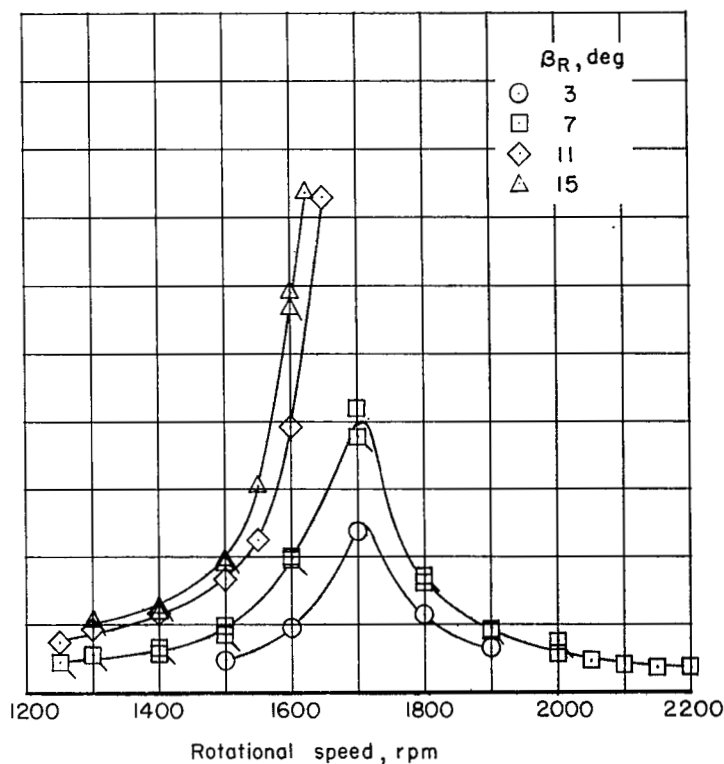
(a) Front propeller.

(b) Rear propeller.

Figure 5.- Variation of blade-passage vibratory torsional stress with rotational speed for front and rear propellers. Six-blade configuration at $x = 0.75$.

Vibratory torsional stresses.- The largest vibratory stresses caused by mutual interference of the propeller blades were found to be in the fundamental torsional mode. Figures 5 and 6 show the variation of the torsional stress with propeller rotational speed for the six- and eight-blade configurations, respectively. Resonance is noted in the vicinity of 1,700 rpm for the six-blade configuration, and 1,300 rpm for the eight-blade configuration. Because of the slight differences in the torsional natural frequencies of the different blades, the stress curves have been drawn to show resonance at the static natural frequency of the blade for which the data were obtained.

Although the maximum measured torsional stresses are below $\pm 6,000$ pounds per square inch, it appears (fig. 5(b)) that larger stresses would have been encountered for some blade-angle tests if the propeller rotational speed had been increased. In view of the possibility of large stresses in torsion for ground operation, care should be taken in the design of a constant-speed variable blade-angle propeller installation to insure that the torsional natural frequency of the blades does not coincide with the blade-passage frequency.

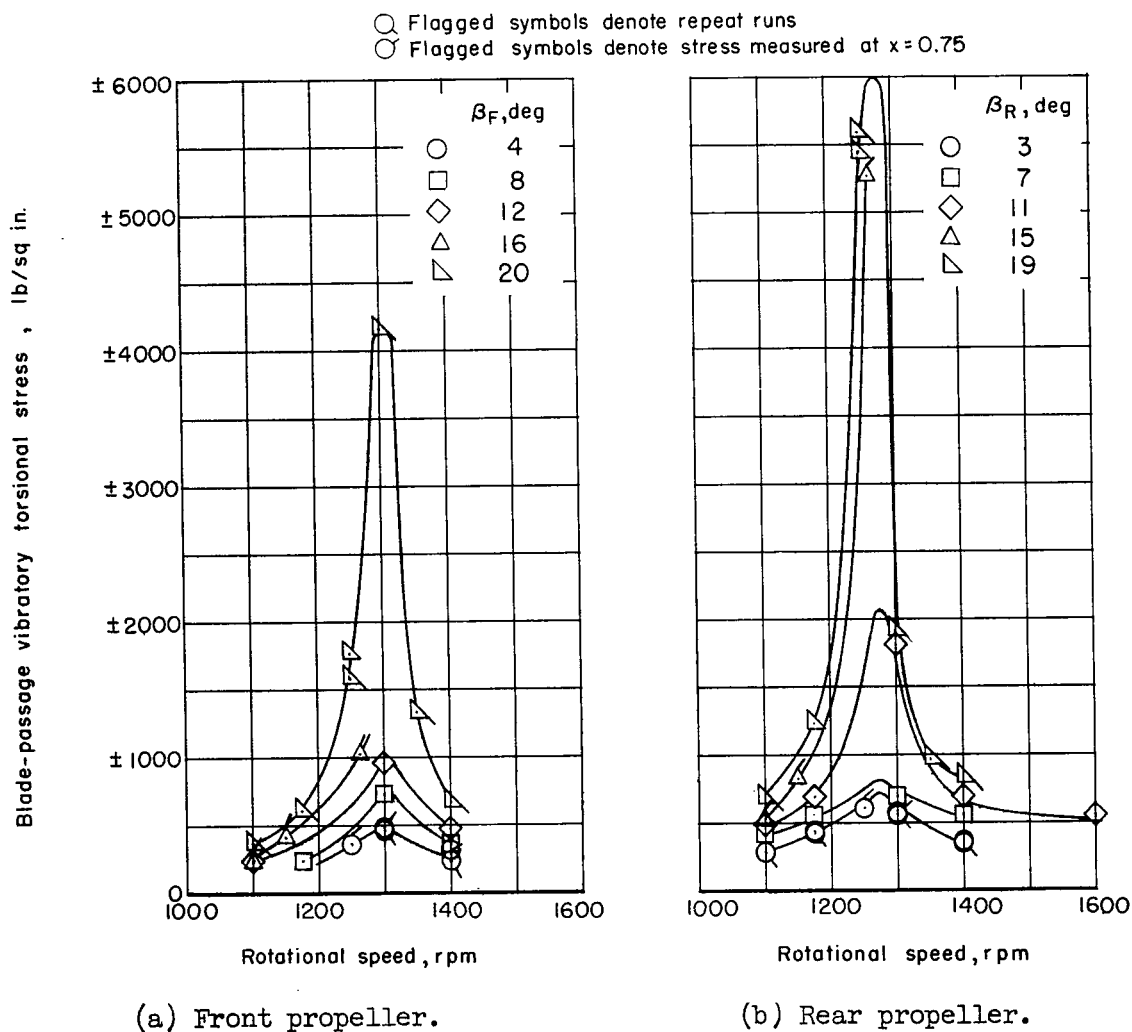
Figure 6.- Variation of blade-passage vibratory torsional stress with rotational speed for front and rear propellers. Eight-blade configuration at $x = 0.75$. Stress measured at $x = 0.30$ but converted to stress at $x = 0.75$ by proportionality factor.

For comparison with the torsional stresses of the six-blade configuration which were measured at $x = 0.75$, the torsional stresses of the eight-blade configuration measured at $x = 0.30$ have been adjusted to values of stress that would have been measured at $x = 0.75$ had the strain gages been operative. The adjustment was made by using factors obtained from the two tests in which the stresses at the two stations were read simultaneously.

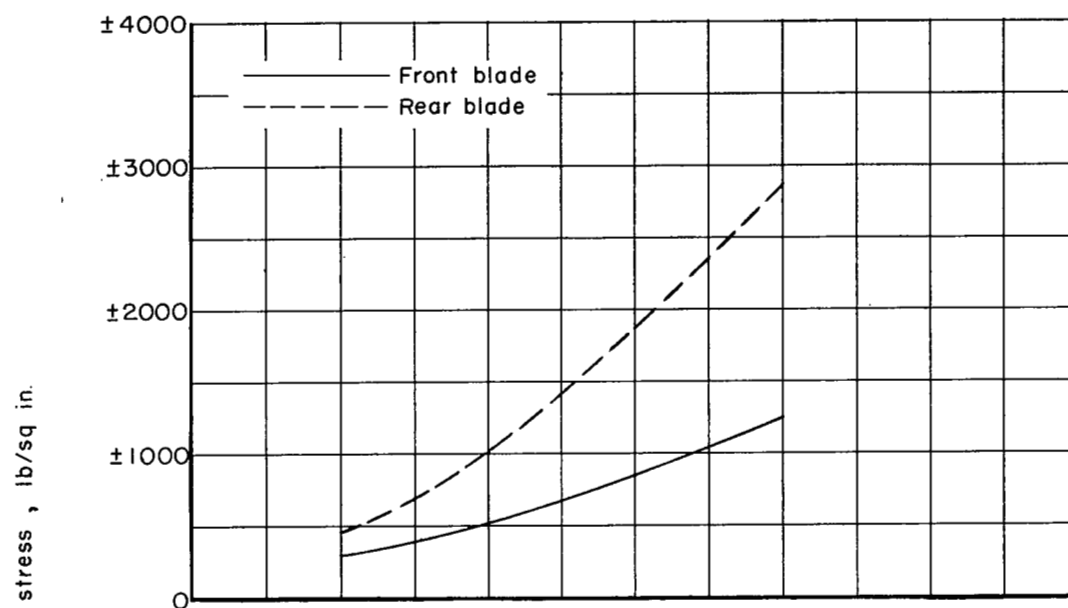
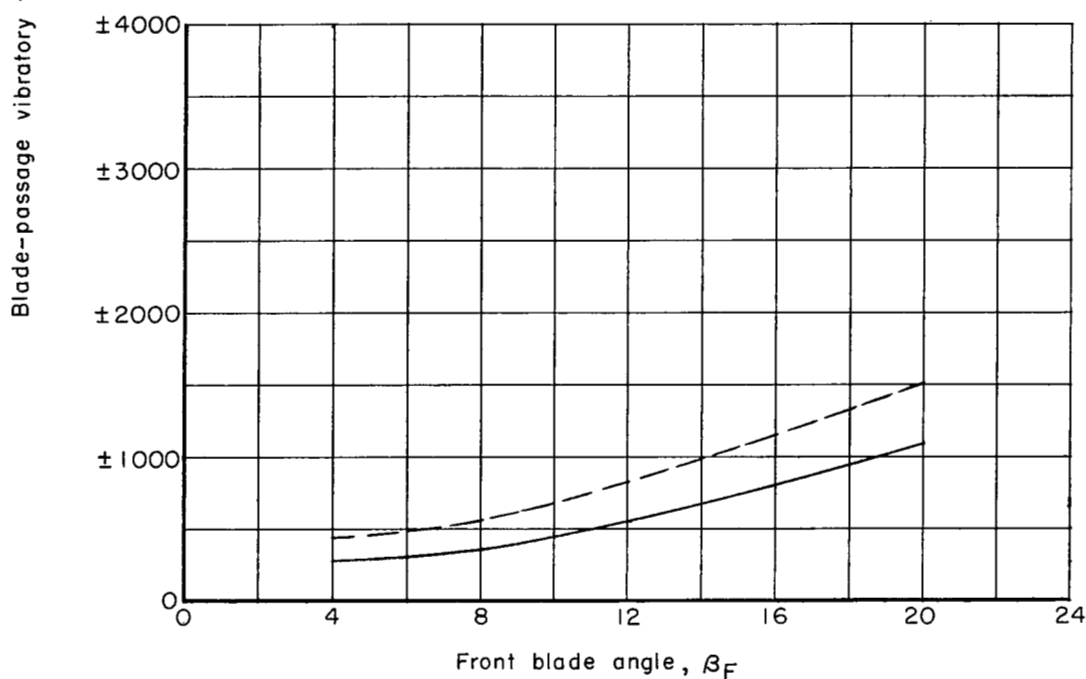
(a) Six-blade configuration. $N \approx 1,700$ rpm.

(b) Eight-blade configuration. $N \approx 1,300$ rpm.

Figure 7.- Variation of blade-passage vibratory torsional stress with front blade angle. $\frac{2\pi nm}{\omega_\alpha} = 0.936$.

In order to show the effect of blade angle on the stress and to compare the stresses of the front and rear components, the stresses were read at the same approach to resonance $\frac{2\pi n m}{\omega_a} = 0.936$ and are presented

in figure 7 as a function of the front-component blade angle. A definite increase of stress with blade angle is noted for all blades. For the data of figure 7, a constant difference in blade angle of 1° between the front and rear components was maintained over the range of blade angle. This constant difference in blade angle does not represent a constant difference in power absorption between the two components. In order to show that the increase of stress with blade angle was caused by the blade loadings and not by the difference in blade loadings, the rear blade angle was set 0° and 2° lower than the front blade angle (12°), to vary the difference in power absorption of the two components. The stresses of each component remained constant for the three tests which represented ratios of rear-component power to front-component power of 1.010, 0.738, and 0.555. Therefore, the increase of stress with blade-angle increase may be attributed to an increase in the loading on the propeller blades. The increase of stress with increased loading is also noticed in a comparison of the six- and eight-blade configuration stresses of figure 7. For any given blade angle over 4° , the stresses of the six-blade configuration which were measured near 1,700 rpm are higher than the stresses of the eight-blade configuration which were measured near 1,300 rpm.

Figure 7 also shows that the rear-component blade stresses were higher than the front-component blade stresses. Such an effect seems possible when it is considered that the rear component operated wholly in the slipstream of the front component, while the front was subjected only to the relatively smaller induced effects ahead of the rear component.

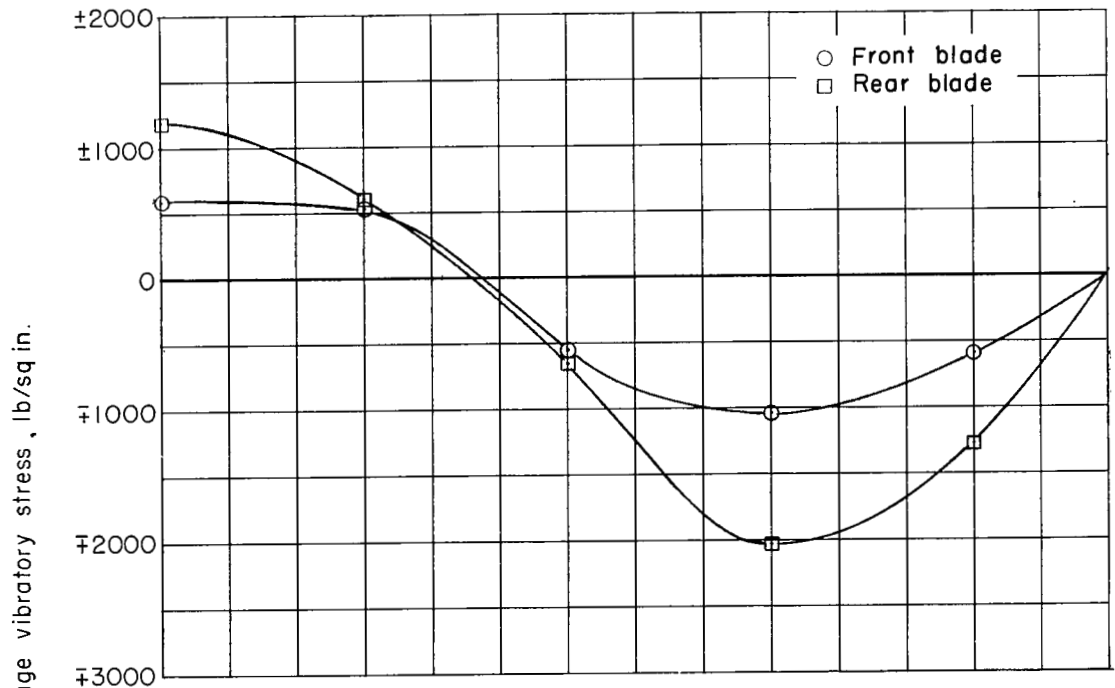
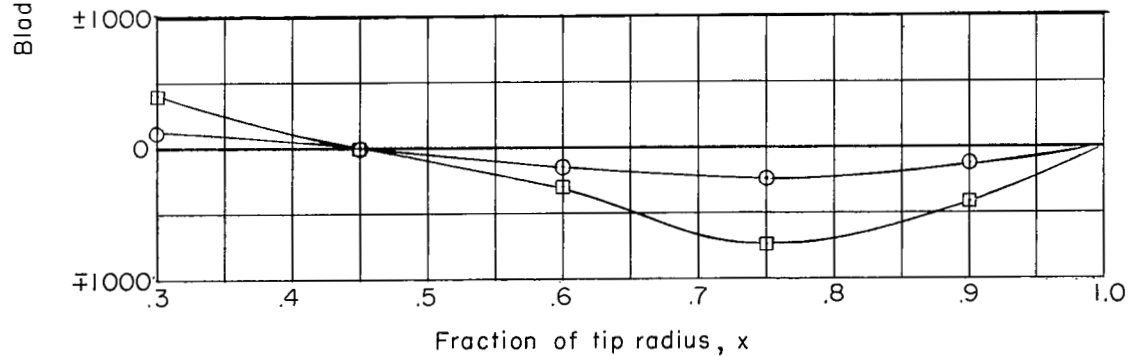
(a) Second flatwise bending mode. 1,000 rpm.

(b) Fundamental edgewise bending mode. 700 rpm.

Figure 8.- Comparison of radial vibratory stress distributions for front and rear propeller blades in two different modes of vibration. Six-blade configuration; $\beta_F(0.75R) = 16^\circ$; $\beta_R(0.75R) = 15^\circ$.

Vibratory bending stresses.— The largest vibratory stresses measured in any bending mode were in the second flatwise bending mode. Figure 8(a) shows typical radial vibratory-stress distributions for the front- and rear-component blades in this mode. The maximum measured stress occurred at the 0.75 station where the stress on the rear-component blade was about twice that on the front blade.

Figure 8(b) shows radial vibratory flatwise bending-stress distributions similar in shape to those of figure 8(a), but resulting from an edgewise bending mode. The shank strain-gage stress readings were very small (less than ± 300 pounds per square inch), but the stresses indicated that the vibration was principally edgewise with respect to the

0.75 radius; this condition would indicate fundamental edgewise bending. Although the vibration mode was edgewise, the coupling effects due to blade twist caused a flatwise stress distribution over the blade similar to second bending. An experimental investigation of the coupling effects of blade twist has been reported in reference 5 in which a flatwise stress distribution similar to third bending was obtained in the edgewise mode of vibration.

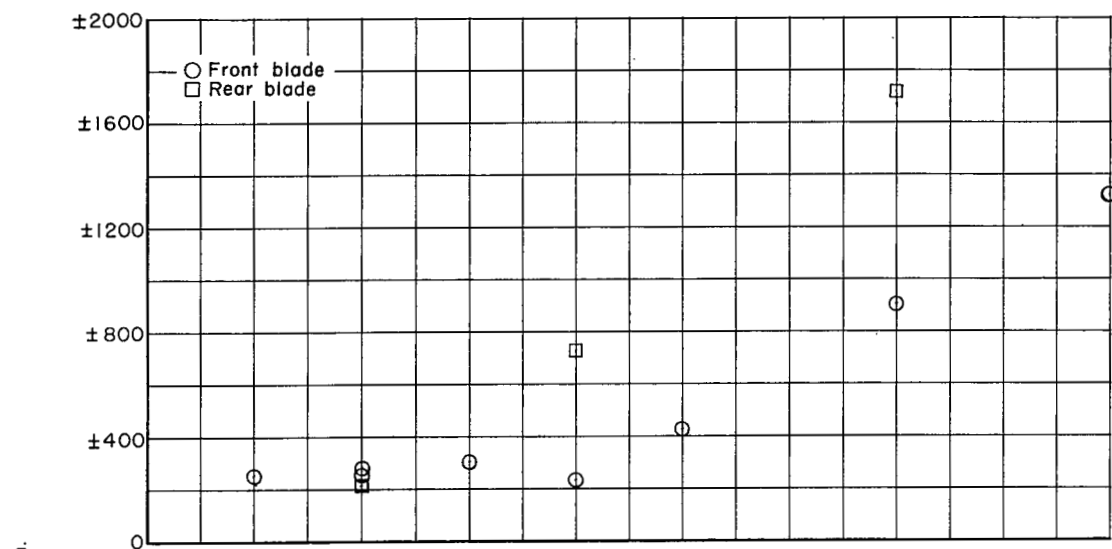
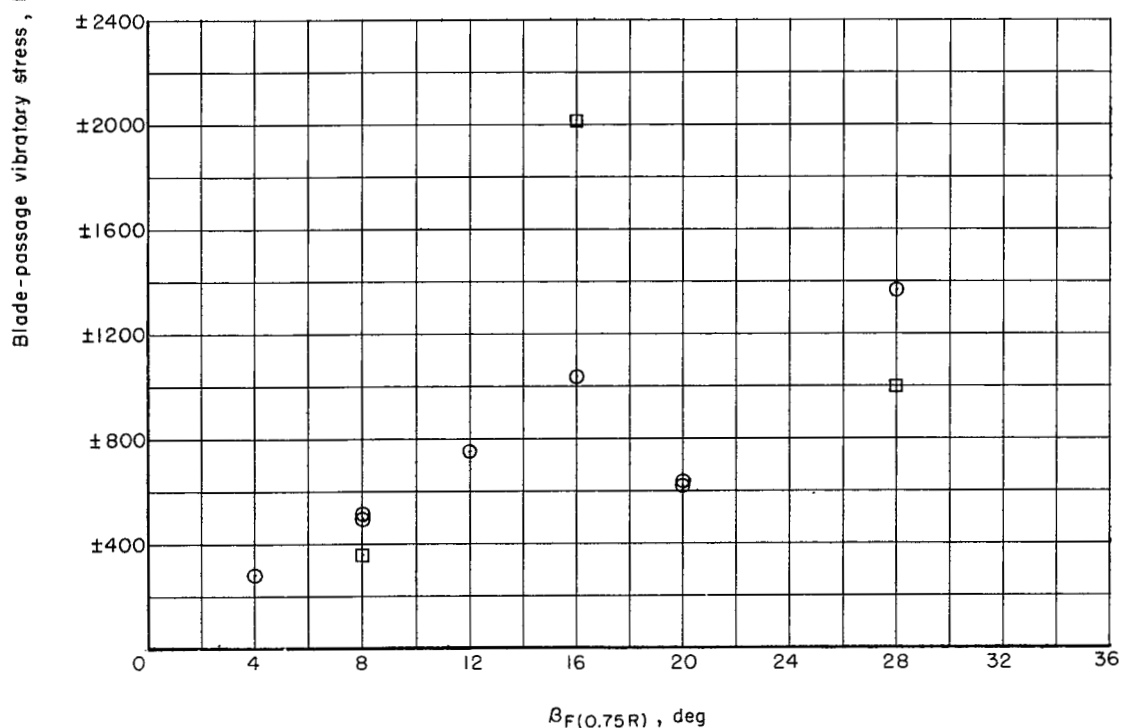
(a) Fundamental edgewise bending mode.

(b) Second flatwise bending mode.

Figure 9.- Variation of maximum measured vibratory stress near resonance in two different bending modes with propeller-blade angle for six-blade configuration. $x = 0.75$.

For the two modes of vibration of figure 8 the maximum measured stress at 0.75 radius is presented as a function of blade angle in figure 9. The stresses are rather erratic, no doubt due to the fact that the resonant stress was not recorded in each instance; but for each mode of vibration, the stress trend increases with increasing blade angle. At the lower blade angles, there is little difference between stresses on the front- and rear-component blades, but at the higher blade angles, the rear-component blade stresses are in most instances higher than the front as was noted for the torsional stresses. The stress levels, however, are low in magnitude and may be considered unimportant.

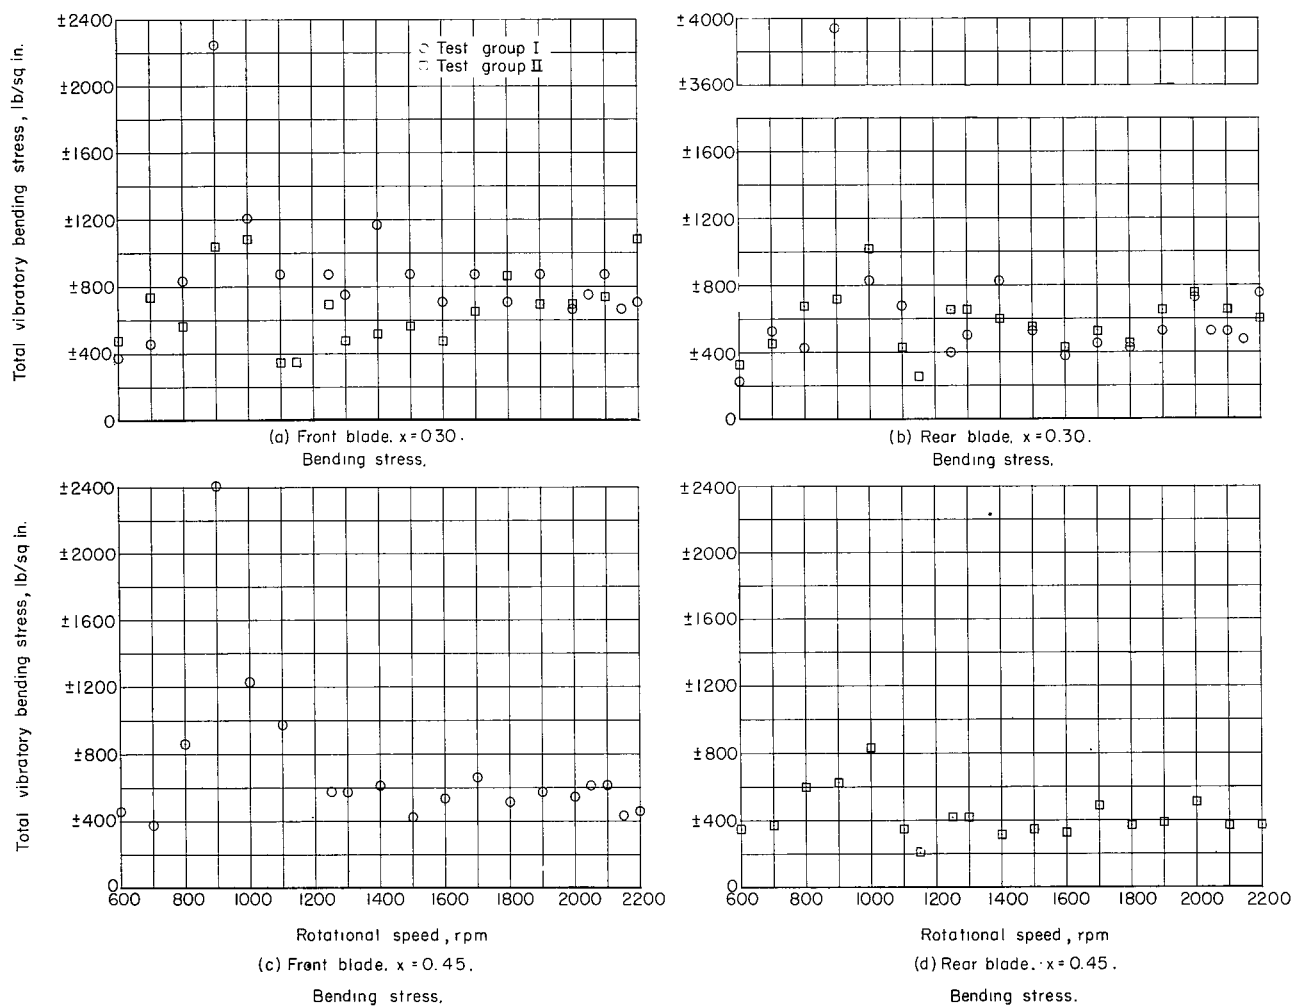
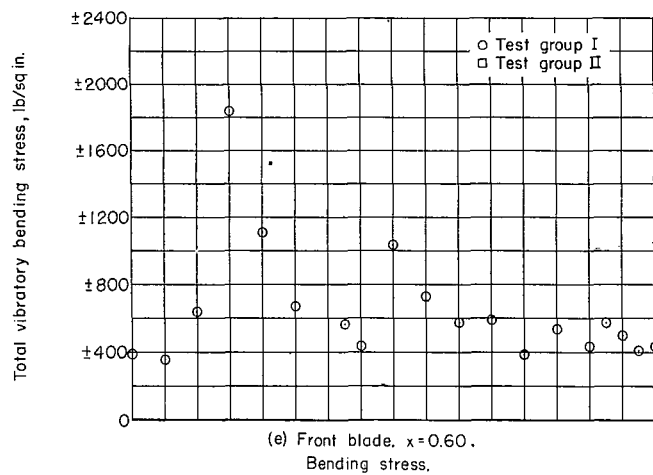
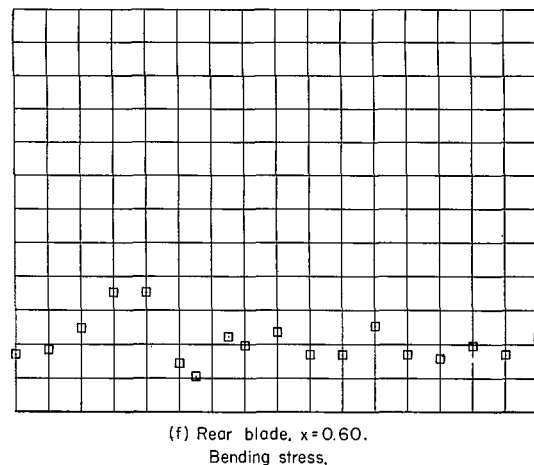
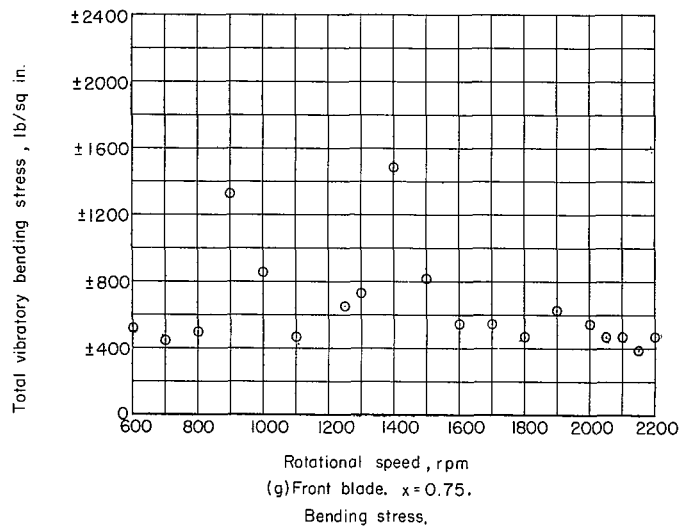
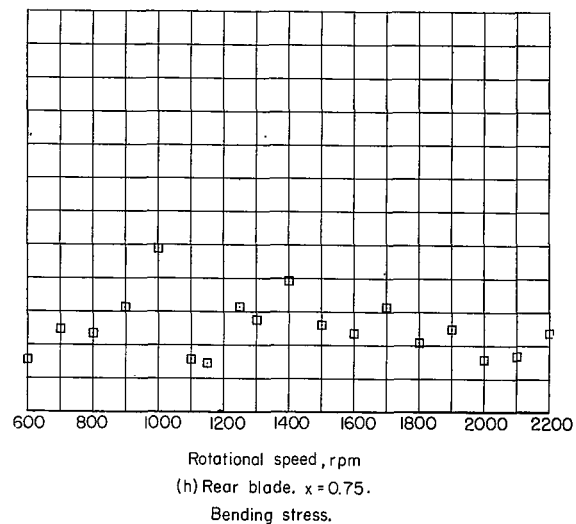
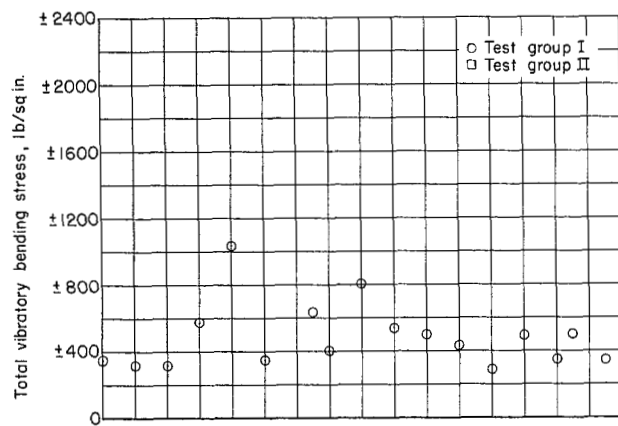
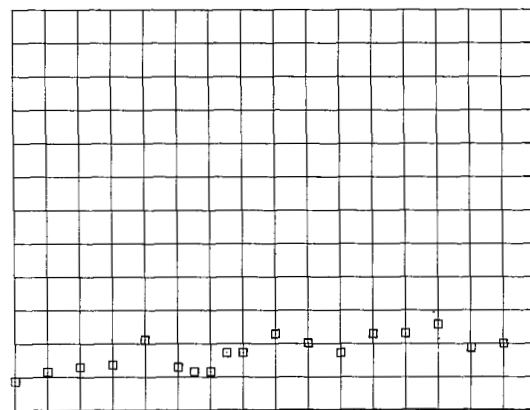
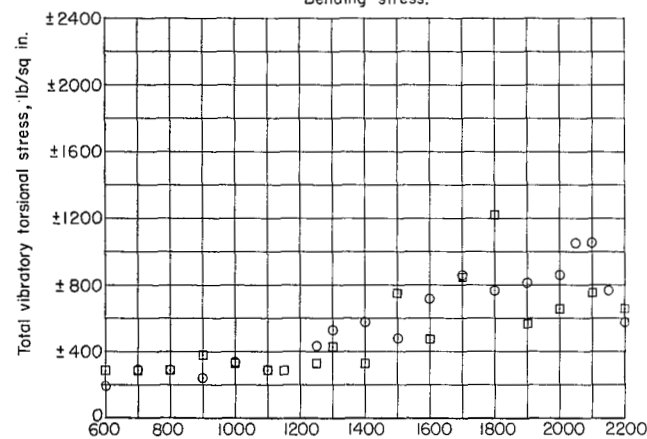
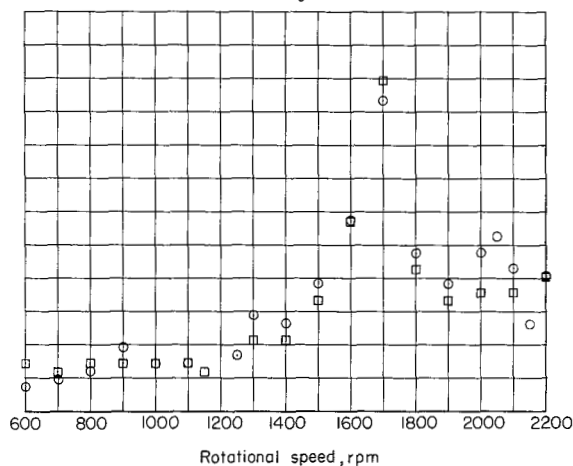
Figure 10.- Variation of total vibratory stress with propeller rotational speed at $\beta_F(0.75R) = 8^\circ$ and $\beta_R(0.75R) = 7^\circ$. Six-blade configuration; test group I.

(i) Front blade. $x=0.90$
Bending stress.

(j) Rear blade. $x=0.90$
Bending stress.

(k) Front blade. $x=0.75$.
Torsional stress.

(l) Rear blade. $x=0.75$.
Torsional stress.

The variations of total vibratory stress with propeller rotational speed for flatwise-bending and torsional vibration in the six-blade configuration at $\beta_F(0.75R) = 8^\circ$ and $\beta_R(0.75R) = 7^\circ$ are shown in figure 10. In general, the shapes of the distribution are typical of all the tests; however, for the higher blade-angle tests, stress levels as much as 100 percent higher than those shown in figure 10 were measured. The only increase in bending stresses over the general level occurred at 900 rpm and is most noticeable in figures 10(a), (b), (c), (e), (g), and (i) for test group I. The stress at the aforementioned rotational speed was resonant and was due to the coincidence of the fundamental natural bending frequency of the propeller blade with an excitation at twice the propeller rotational frequency $2xP$. These $2xP$ stresses were attributed to a cross wind in the test stand of about 3.3 feet per second. Although the primary effect of a cross wind on propeller operation is to cause a $1xP$ vibration, it has been shown in the analysis of reference 6 for a helicopter in forward flight, which closely simulates the present cross-wind-propeller condition, that the $1xP$ excitation is not a pure sine wave and that a $2xP$ component exists. The $2xP$ excitation is small with respect to the $1xP$ excitation, but large $2xP$ stresses can result from amplification of the stress at resonance. Figures 10(a) and (b) show that, for a test made at a different time (test group II) during which no wind

was blowing, no large increase in stress occurred near 900 rpm. Reference 6 shows that the $2xP$ excitation varies as the square of the cross-wind velocity. Therefore, the operating limit of the vibratory stress ($\pm 6,000$ pounds per square inch) set for this investigation would have been reached with a cross wind of about 4.2 feet per second if the maximum stress of figure 10(b), ($\pm 3,940$ pounds per square inch obtained during a cross wind of about 3.3 feet per second) were to be extrapolated. Thus it appears that this propeller may encounter large $2xP$ stresses during normal ground operation.

The only other large increase of vibratory stress over the general stress level was in the torsional mode of vibration and is shown in figures 10(k) and 10(l) around 1,700 rpm. Analysis indicated that the stress increases were due to mutual interferences on the front and rear components of the propeller which have been more fully discussed in the preceding sections.

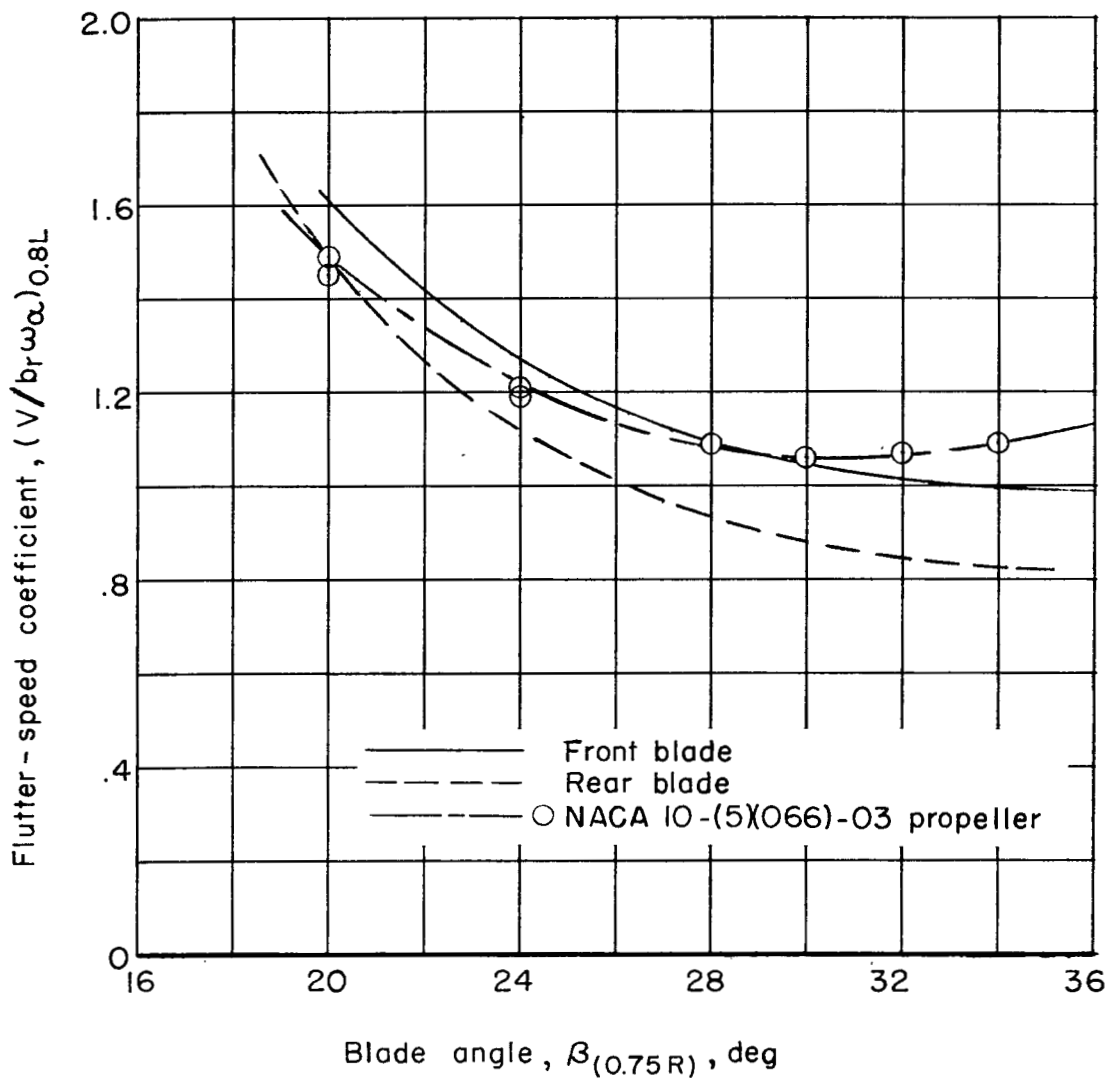
Figure 11.- Comparison of the stall-flutter boundaries of front and rear propeller blades of six- and eight-blade configurations. Torsional stress = $\pm 2,000$ lb/in.²; flutter characteristics of NACA 10-(5)(066)-03 single-rotating propeller of reference 7.

Partial stall-flutter boundaries were obtained for the front and rear components of both the six- and eight-blade configurations. Figure 11 shows these boundaries which were based on a torsional stress of $\pm 2,000$ pounds per square inch at the torsional natural frequency of the blade. The stress value of $\pm 2,000$ pounds per square inch was chosen for comparison of the flutter characteristics of the propellers because it was the largest stress measured for some tests. A stress value had to be chosen as a flutter criterion because the flutter was intermittent in nature. No consistent differences were noted between the flutter characteristics of the six- and eight-blade configurations. No significance can be attached to this occurrence because the repeatability of flutter points was frequently good to only 10 percent of the flutter-speed coefficient. The rear-component blades had a flutter-speed coefficient

$\left(\frac{V}{b_r \alpha_a} \right)_{0.8L}$ that was about 0.20 less than the front blades. It could not

be determined from the present investigation whether the lower flutter-speed coefficient would be realized if sustained flutter were to be encountered. However, the onset of stall flutter occurs on the rear-component propeller at a lower rotational speed than the front component, and it is thought that this effect may be partially caused by excitation from the wake of the front component, even though the frequency of the mutual excitation was not at the fundamental torsional natural frequency of the blade.

NACA 10-(5)(066)-03 three-blade propeller reported in reference 7 have been included in figure 11. A slightly different blade reference station for the flutter-speed coefficient was used in reference 7 so the data have been adjusted to the same blade reference station as that used for the present tests. The NACA 10-(5)(066)-03 blades were chosen for comparison because they had the same design lift coefficient at the 0.70 station as the dual-rotating propellers and had a difference in thickness ratio of only 0.016.

The minimum flutter coefficient of the single-rotating propeller is 1.06 while that for the front component of the dual-rotating propeller is 0.99. It should be noted that the flutter curve for the single-rotating propeller marks the boundary of sustained flutter while the curve for the dual-rotating propeller marks a certain stress value in intermittent flutter. If sustained flutter had been reached on the dual-rotating propeller, better agreement with the minimum flutter coefficient of the single-rotating propeller might have been obtained.
